CONDITION REPORT

ST MICHAEL'S CE PRIMARY GRIMSARGH

**Re: ST MICHAEL'S CE PRIMARY
Condition Inspection and Report**

Roof Survey Report

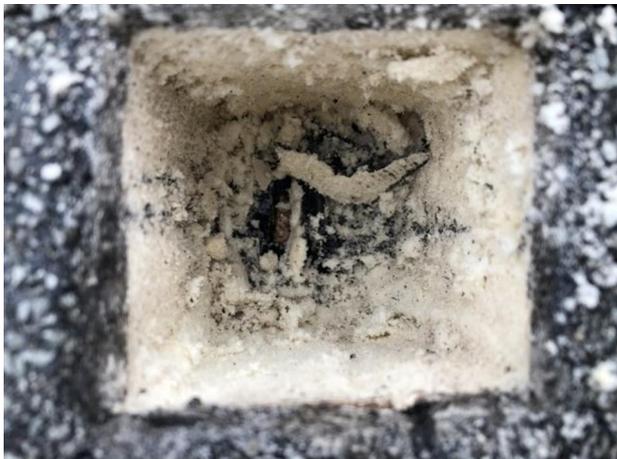
Overview of the core sample taken. There is a good level of insulation and appears to be dry and generally free from water damage. This roof can be overlaid following suitable repairs.

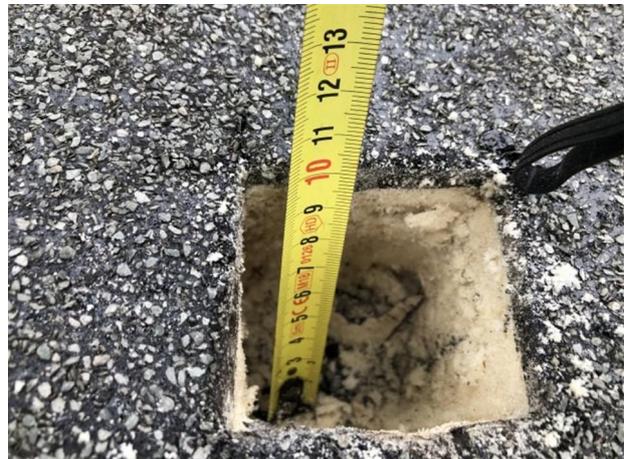
Confirmation of the 90mm of insulation within the build-up on roof 1. Due to the adverse weather and access restrictions, we were unable to take a sample of roofs 2 and 3. A visual inspection was undertaken.

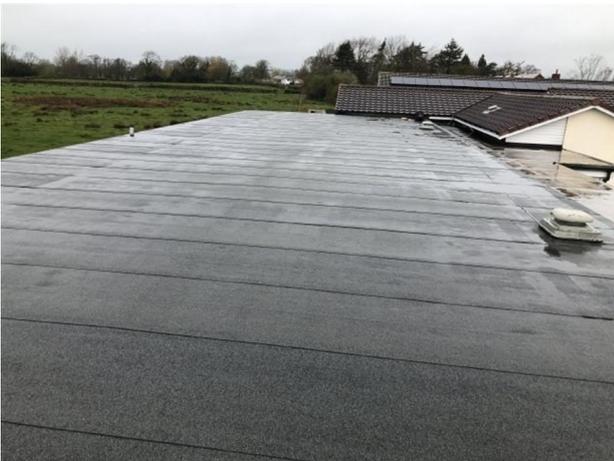
General view of roof area 1.

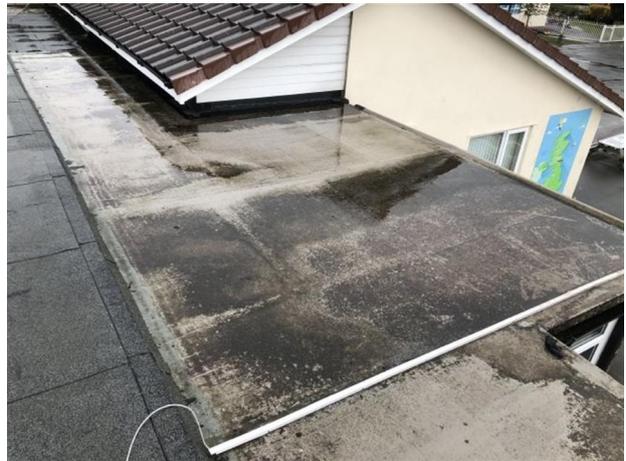
General view of roof area 2.

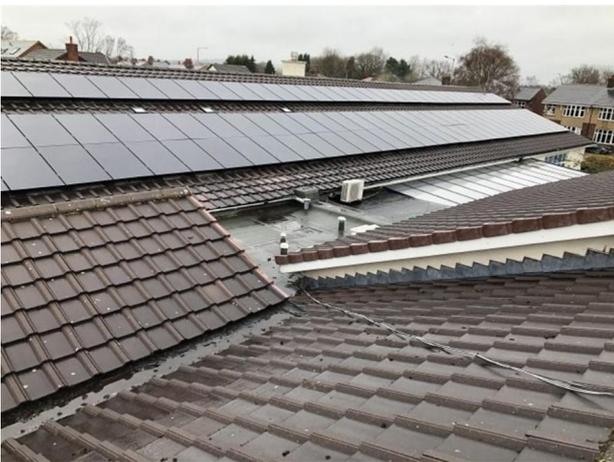
Overview of roof area 3. This could not be accessed due to the glazed canopy at the front of the building. Visually, the waterproofing appears to have been poorly installed and should be removed and replaced.

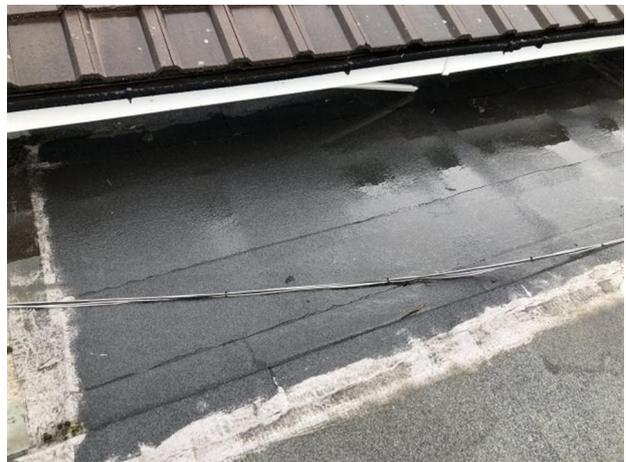
There have been a number of patch repairs undertaken due to water ingress into the building on roofs 1 and 2, in particular where the two areas meet.

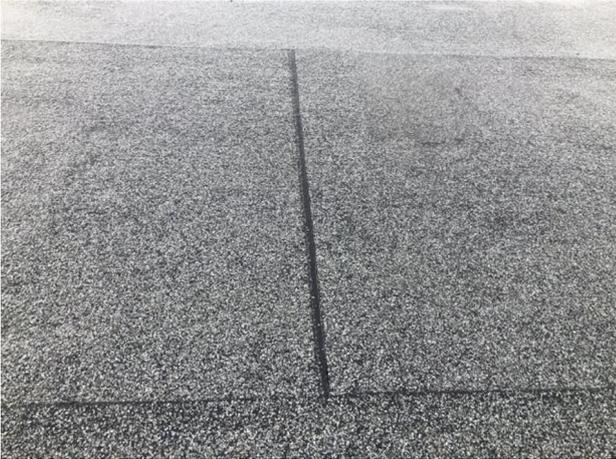
The laps on roof area 1 are beginning to shrink and pull apart. This area is in a good enough condition to overlay.

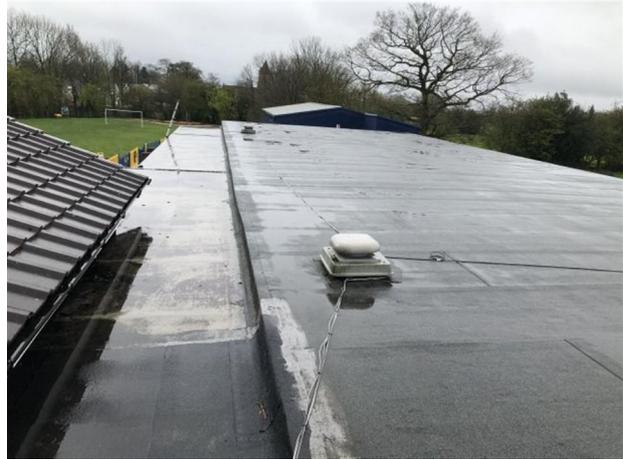
View of the problematic junction between roof areas 1 and 2.

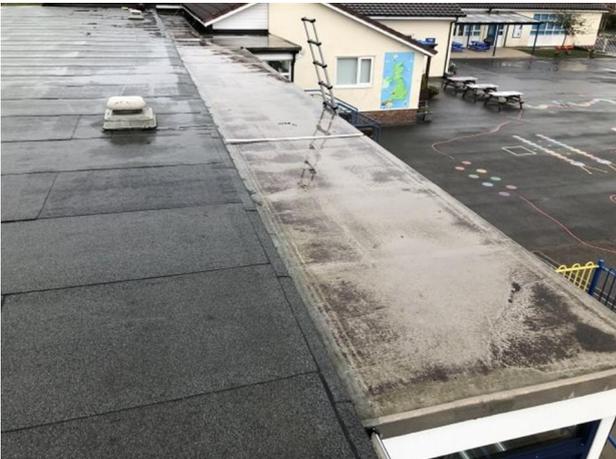
Roof area 2 is fibreglass and has hairline cracks throughout. This has been installed directly to untreated plywood which will deteriorate over time. This should be stripped, re-deck and replaced with a suitable system.

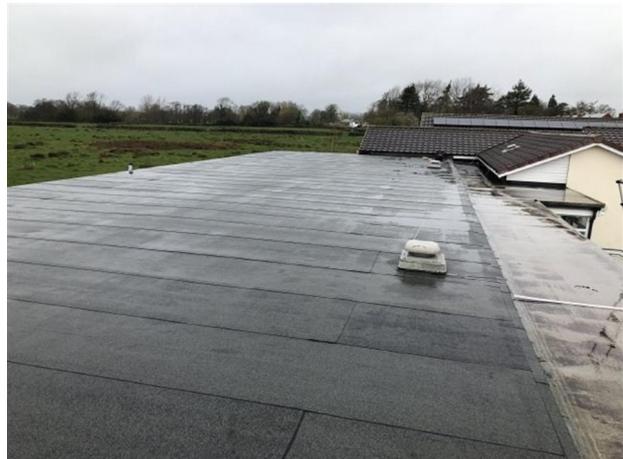
Another general view of roofs 1 and 2.

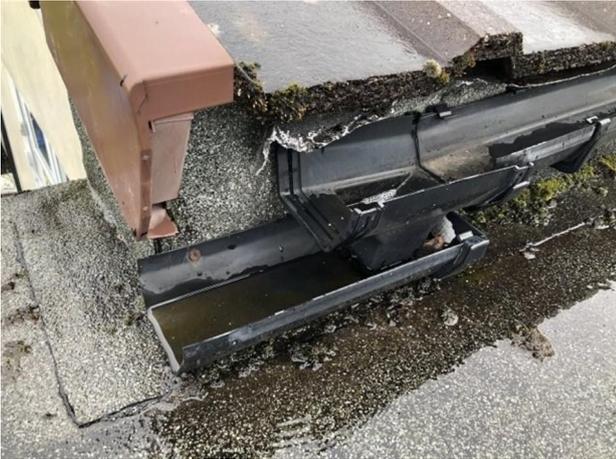
Example of the plastic rainwater goods to the pitched roofs.

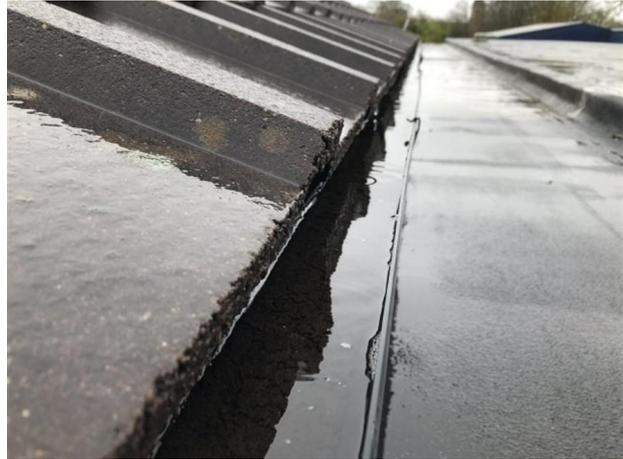
The rainwater goods are blocked and water is overflowing.

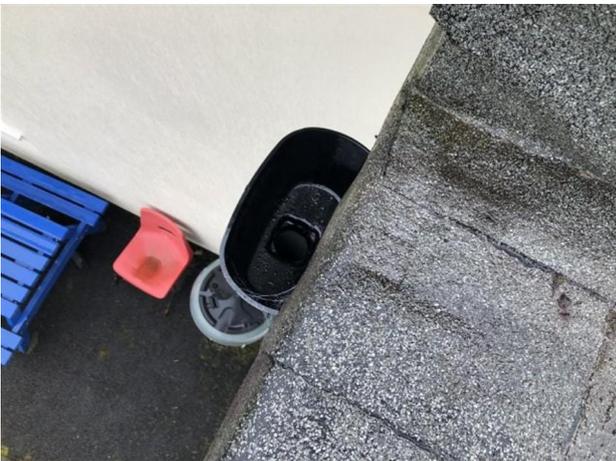
Roof 1 discharges onto roof area 2 which is ponding. There is also 1no chute on roof 1.

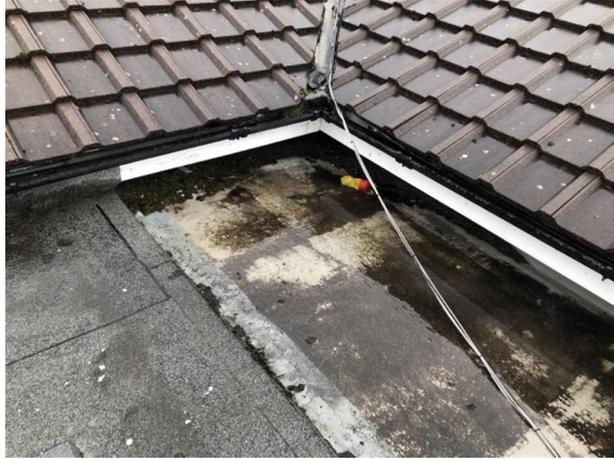
When the roofs are refurbished its important that the lower courses of tiles are removed and the change in level ply-clad. This will enable the new system to be taken onto the pitched roofs and terminated correctly. These areas are potentially an area of water ingress at present.

The lower courses of tiles/ slates from the adjacent abutment will need to be removed in order to allow access to re-waterproof the upstand behind and if necessary extend the supporting lay-board.

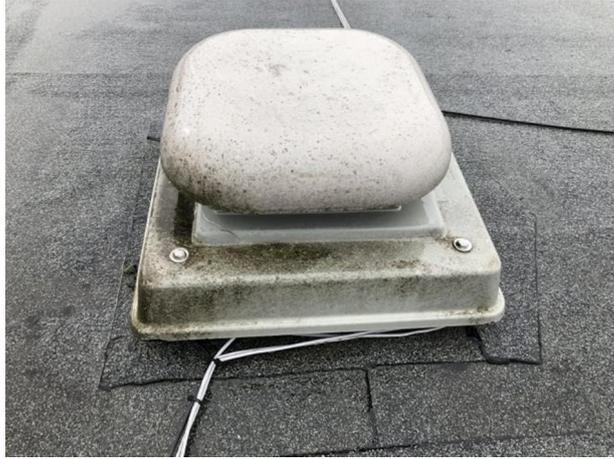
The upstand height on the 2no ventilation units on roof 1 is far too low and these will need to be raised.

The existing powered extractor vents need to be removed to allow the kerb to be raised to provide the required minimum height.
